Commercial Property Inspection

4 North Street
Plymouth, MA

February 29, 2020

Re: Commercial Property Inspection
4 North Street
Plymouth, MA

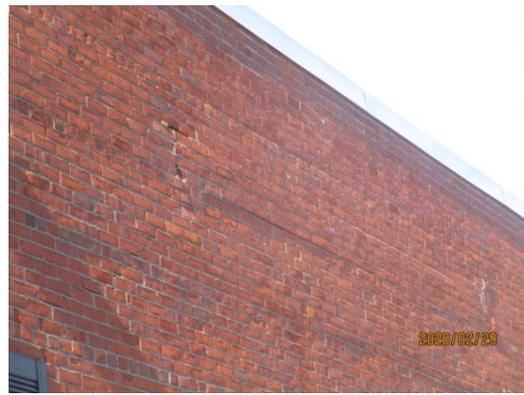
- Inspection of exterior brick siding and cladding system, most notably on the right side of the building, had numerous areas of loose and flaking mortar joints, spalling brick, cracks, and bulging and movement of exterior brick cladding. Further review, assessment, and numerous repairs are recommended for the exterior cladding of this building by qualified contractors.

bulging and cracked bricks

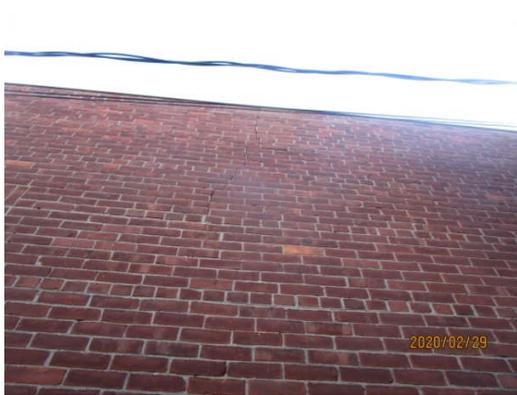
Loose mortar joints

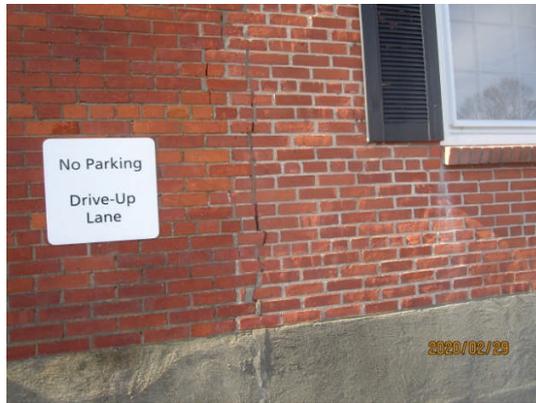
cracks, bulging

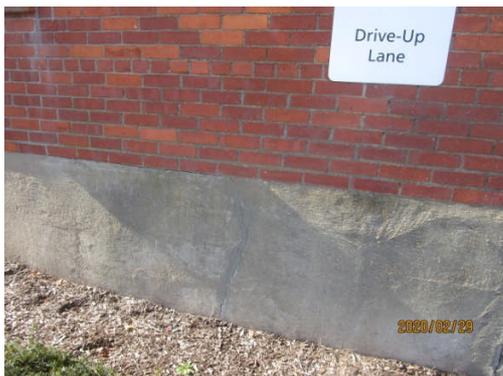
- Inspection of foundation indicated overall fair condition. However, we observed one, several moderate sized cracks at the right section interior of building on foundation wall.

Crack on foundation

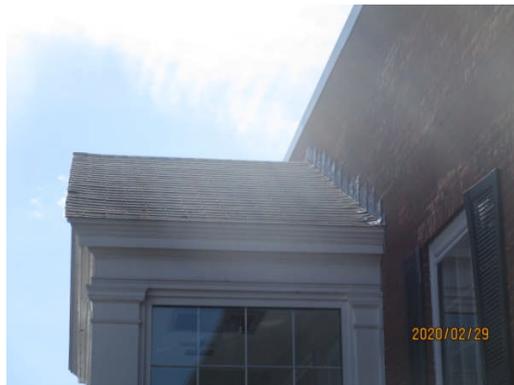
- Inspection of the slate roof covering indicated fair condition. We observed numerous cracked Slate tiles which should be repaired. Flashings in this area were loose and improperly secured. Inspection of the right side small area of gable pitched foyer with three tab asphalt shingles indicated fair to poor condition. The small area of shingles showed signs of deterioration and nearing the end of their expected useful life. Replacement of the shingle should be anticipated within the next 1 to 3 years.

shingles poor condition

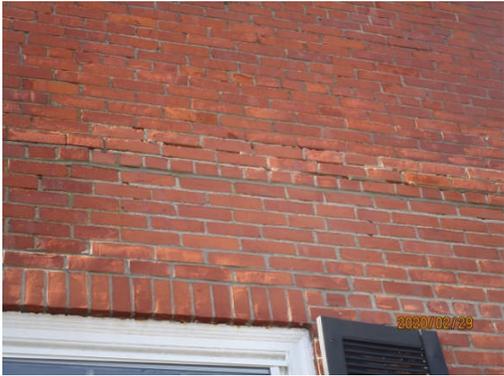
Bulging brick right side

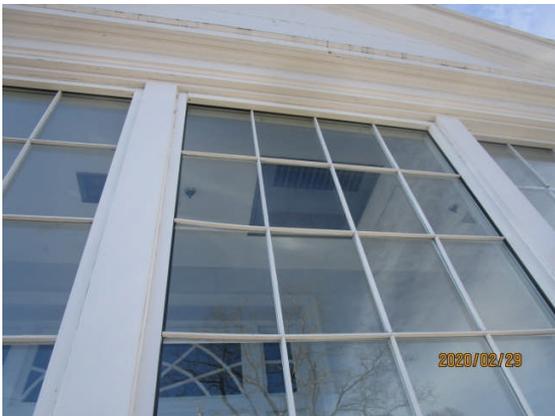
- Windows throughout this building are older original Windows units. Numerous cracked Windows were observed, Windows are difficult open and close, some Windows stuck shut, improper locking systems on Windows, etc. Windows are near the end of their useful life and replacement is recommended.

Windows poor condition. Right side

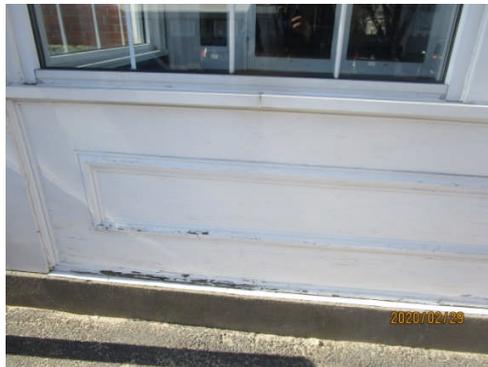
- The right side glass, and wooden, foyer entrance is in overall poor condition. Windows are deteriorated, rotted, and leaking. Exterior trim, and wood is rotted. Major repairs to this entire vestibule area is required.

wood rot, water damage

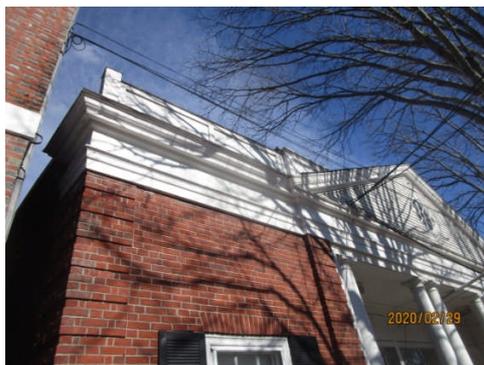
improper roof drainage

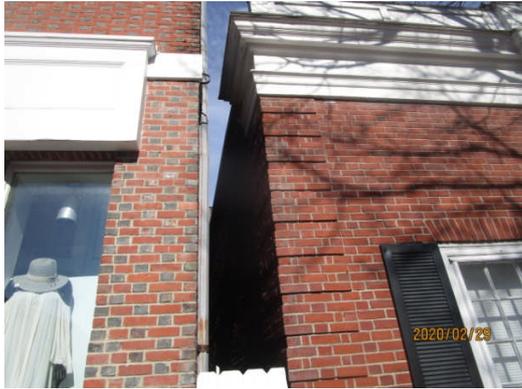
- Recommend post emergency evacuation plans throughout the building.
- Building is extremely close to adjacent building on North Street with potential fire hazard and shares fire escapes.

building close together

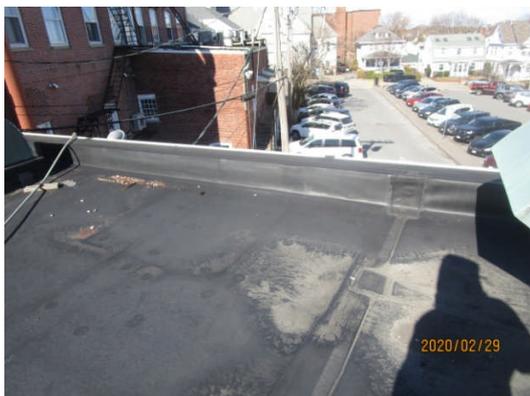
Previous standing water

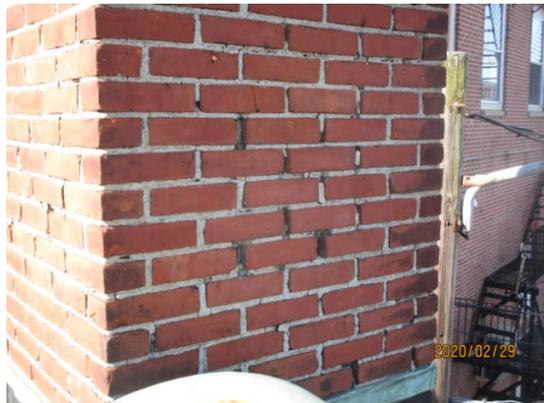
- Inspection of the rear side chimney indicated numerous cracks on bricks, some spalling, deterioration, and joints loosen flaking. Recommend qualified contractor for re-pointing and repair of chimney, along with interior inspection of flue for this chimney, including, cleaning, inspection, assessment, repairs, etc.

loose mortar joints chimney

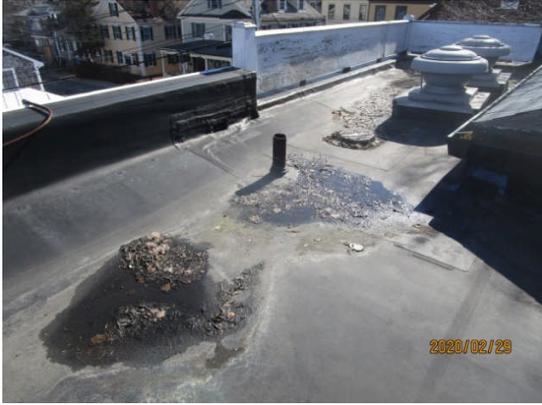
standing water front right

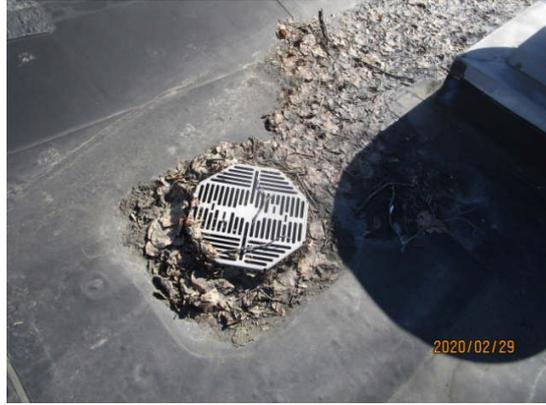
improper drainage

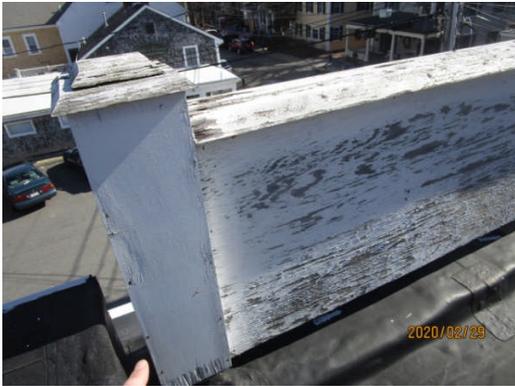
- The wooden safety fencing and guard rail on top of the front side of the roof near Gable section is in overall poor condition. The guard is loose, improperly secured, and dry rotted. Recommend replace this guard rail.
- The wooden gable ends of the pitched section of roof for the slate roof covering have moderate wood rot, deterioration, and damage. Recommend repair replace all components associated with these defects, including painting as needed.
- The rear side metal fire escape steel fire escape stairs have signs of corrosion, and needs immediate assessment and inspection and certification by licensed architect every five years. Recommend further review of rear side, fire escape stairs, especially fasteners to the building.
- Recommend environmental site assessment by qualified professional for property.

Loose rotted guard rail

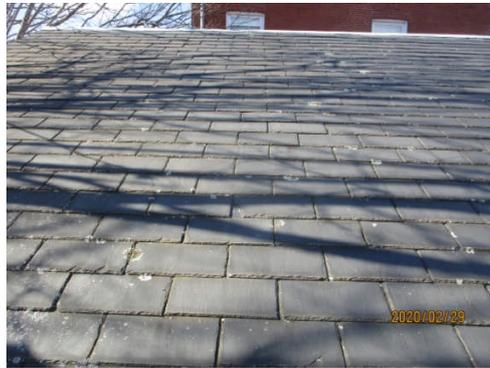
cracked Slate tiles

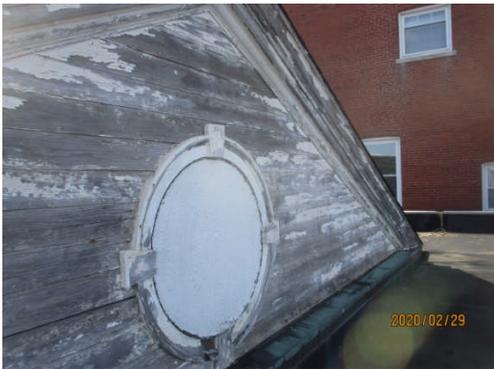
Rotted wood

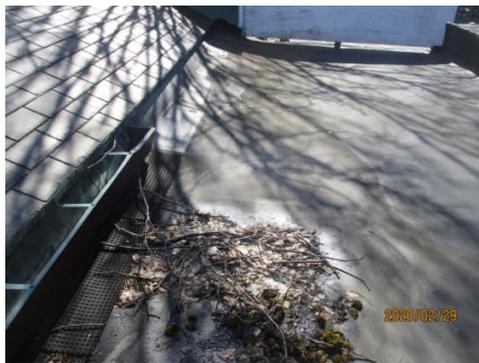
debris, improper drainage

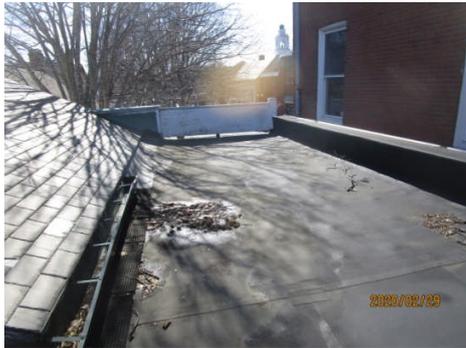
Improper drainage front left

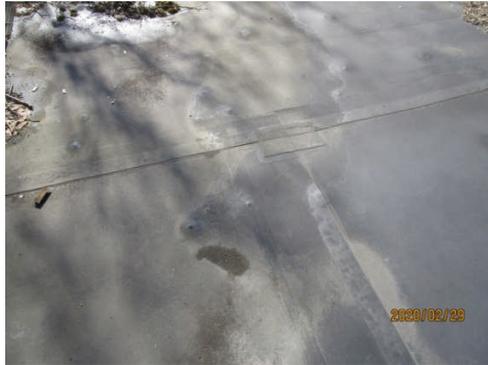
- Inspection of the EPDM membrane indicated overall fair condition. We observed some protruding fasteners at the front left side of the roof near the pitched slate roof. We also observed the membrane to be improperly secured in this area. Signs of improper drainage and standing water were observed at the front right side of the roof also near the pitched gable slate roof. Signs of previous standing water were also observed at the rear side of the roof. Roof drain was clogged, debris was on roof in several areas. Water fails to be properly directed towards the roof drain. Only one roof drain is present for the roof surface. It also appears roof drainage is improperly directed to the front left side of the roof where no roof drainage is present. Inspection of roof drainage gutters indicated heavy dirt and debris inside gutters and need cleaning. Inspection of membrane seams indicated overall fair condition. No major defects observed. Flashings were observed to be in satisfactory condition. No signs of leaking to interior of building were observed.

fasteners protruding from membrane

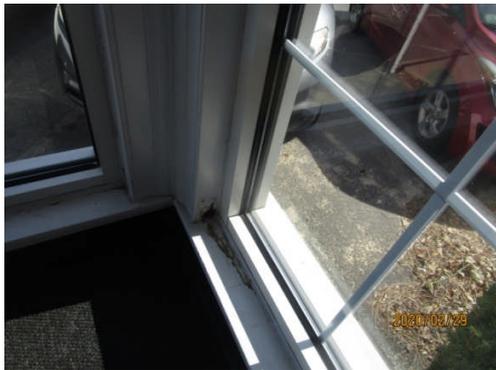
Leaking Windows

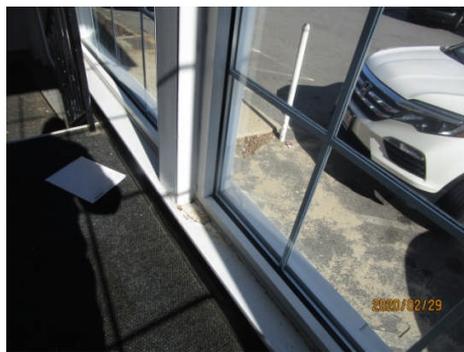
leaking Windows

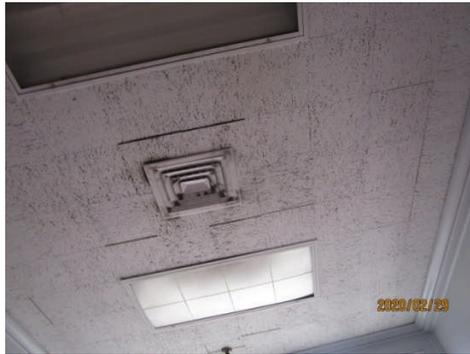
dirt on HVAC diffusers

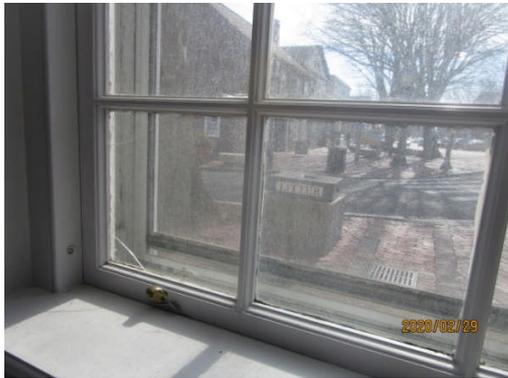
Cracked window

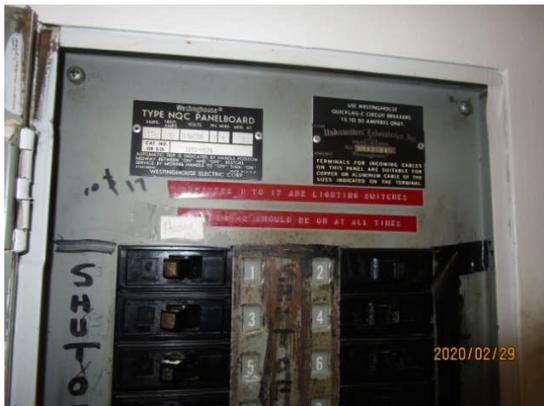
- Inspection of several sub panels in the first floor and within the basement indicated old original equipment, some updated equipment in panels, missing knockouts on electrical panels, safety hazards, old original , and antiquated equipment, several panels were stuck shut, and not accessible for inspection.

Old, antiquated electrical subpanel

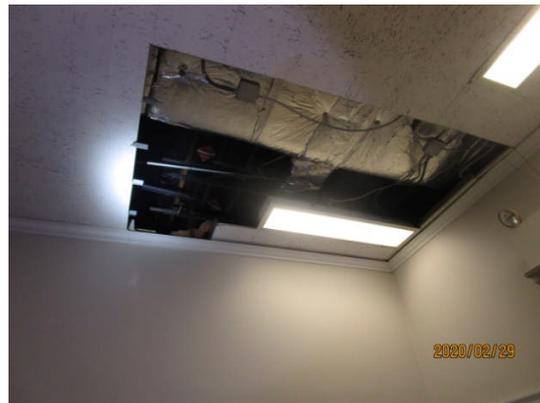
- Recommend full ADA review by licensed architect as needed.
- Inspection of interior ceilings throughout office area indicated overall good condition. However, we observed numerous ceiling tiles which were missing on the first floor.

missing ceiling tiles

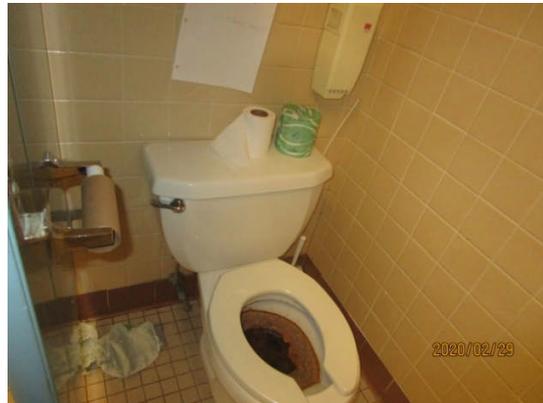
- The bathrooms in the first floor and overall poor condition. Improper drain material with accordion pipe was observed, one sink cold water was turned off, one sink was leaking, one fixture was broken, one toilet was loose at the floor, and one bathroom was complaining nonfunctional. All bathrooms in the first floor of this building are non-ADA compliant. Recommend licensed architect for further review of all bathrooms, interior, and access to all areas of the building, and exterior, parking, etc. by licensed architect.

first floor bathroom, poor condition

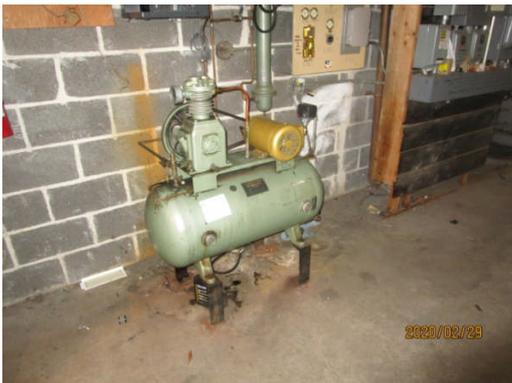
Old compressor units, basement

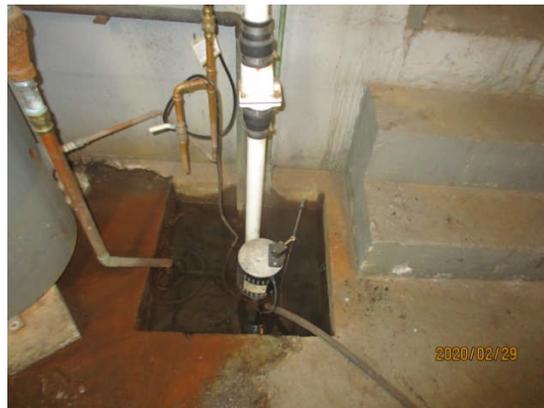
- The circulating pump on the boiler feed tank has a large leak and the associated sump pump is seized and rendered inoperable. Both pumps need immediate repair.

sump pump rear side, nonfunctional

- A certified mechanical company should be hired to repair the circulating pump on the boiler feed tank as it has a large leak and they also need to repair the associated sump pump as its seized and rendered inoperable. The mechanical company should also run the heating and cooling system through several cycles to confirm proper operation and calibration.

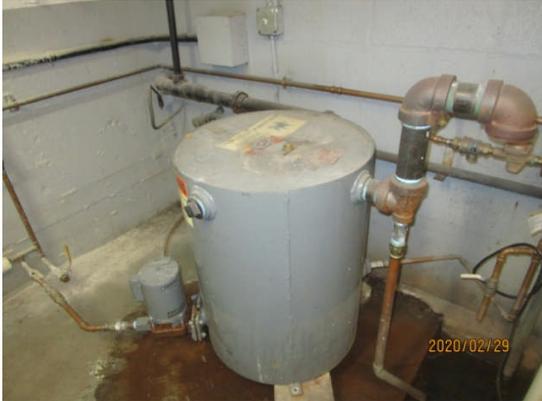
Fair condition. Condensate return pump needs repair.

Condensate pump needs repair, leaking

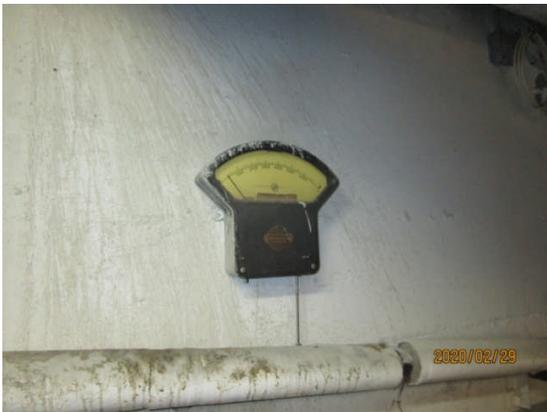
- We observed an old antiquated oil gauge in the boiler room on the exterior foundation wall. This gauge may be associated with exterior underground fuel oil storage tanks. We highly recommend environmental due diligence.

Oil gauge

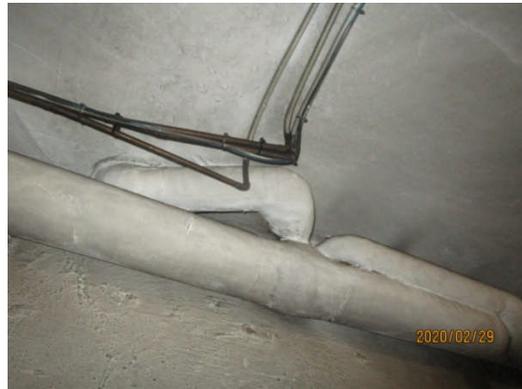
- Stairs leading to the basement rear side are missing handrails. Recommend install handrails.
- We observed numerous areas of the basement heating system and flooring within the building that have the potential for containing asbestos materials. Based on the age of this building, we highly recommend an asbestos survey by qualified professional along with a lead-based paint survey.

potential asbestos

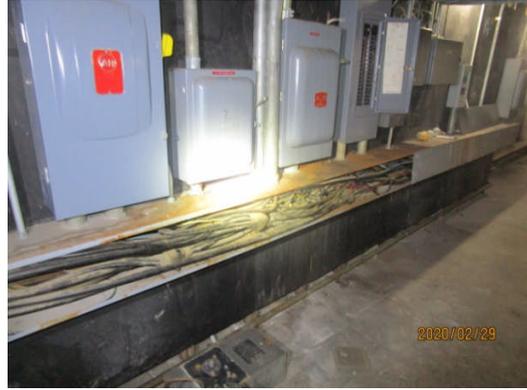
- Several open electrical junction boxes with exposed wires were observed throughout the basement of this building. Several electrical outlets on the first floor did not have power. Bathrooms are missing proper GFCI outlets.

open exposed wires

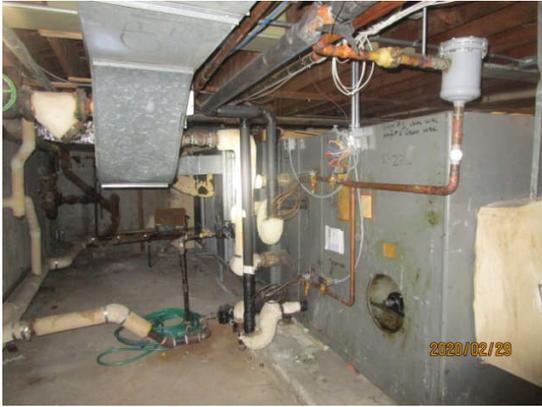
- The basement air handler is past its useful life expectancy per industry standards and escalated maintenance and repair costs should be expected riot to complete component replacement for this air handler. Expect significant costs for replacement.

Main air handler, basement, old

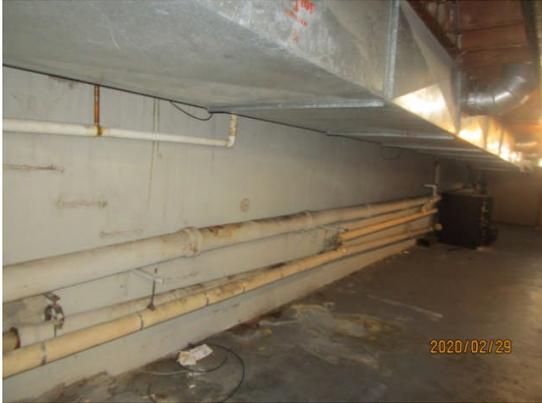
- Inspection of cast-iron drainpipes, most notably right side of building near foundation indicated moderate to heavy corrosion and pitting present on the pipes. The pipes appear to be properly secured and pitched and no leaks were observed at time of inspection. However, these pipes are pitched in two different directions indicating to likely discharge locations to city sewer. Access to underground exterior components of drain and water supply are not accessible and within the scope of this inspection.

Cast-iron drainpipes, corrosion, pitting

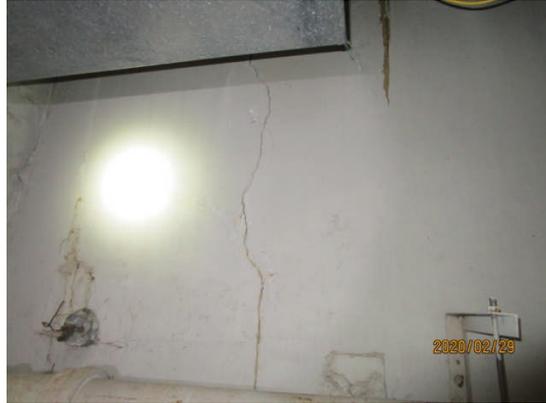
crack right side foundation

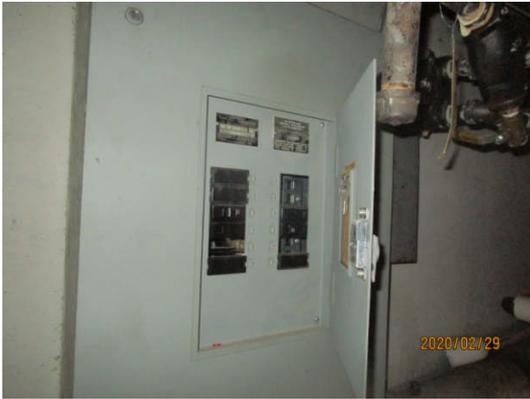
Old electrical panel, missing knockouts

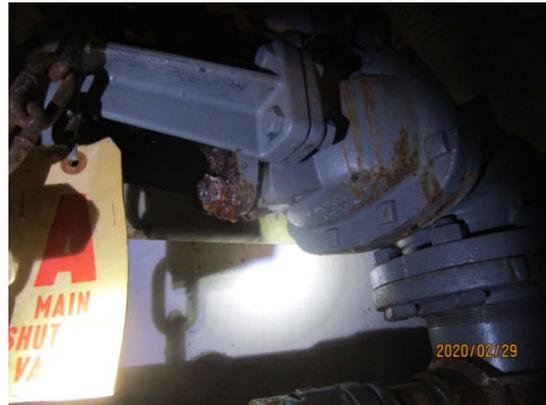
- The building is equipped with an automatic fire sprinkler system. Inspection of the main control valves in the basement front side near main water valve indicated poor condition. The valve was severely corroded and has a small drip leak. Inspection of several sprinkler valves throughout the building indicated heavy dirt and debris on sprinkler valve heads. Last inspection tag on valve indicated inspection and testing in 2019. We recommend immediate inspection, testing, assessment, and repair of entire fire sprinkler system by qualified professional.

leaking main sprinkler valve, corrosion

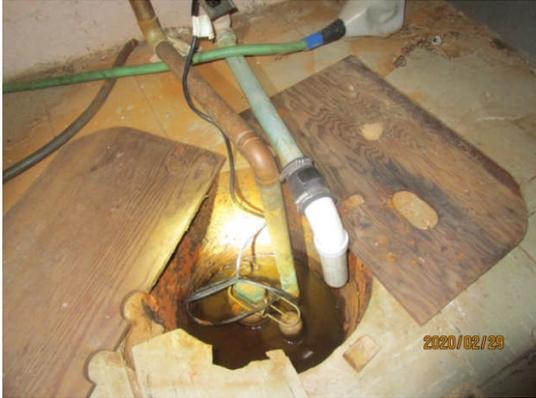
- We did not observe conditions indicating that the primary structural steel framing or wood framing of the building is in need of immediate major repair or that is not performing its intended function. Recommend normal maintenance and periodic monitoring
- The rear side sump pump in the boiler room failed to operate at time of inspection. And was full of water. Recommend immediate repair to rear side sump pump. It appears sump pump water is being discharged to city sewer. Recommend qualified drainage contractor for further review of basement drainage, drainage, discharge, and dehumidification within the basement. Front side sump pump is improperly wired, and needs repair.

front side sump pump

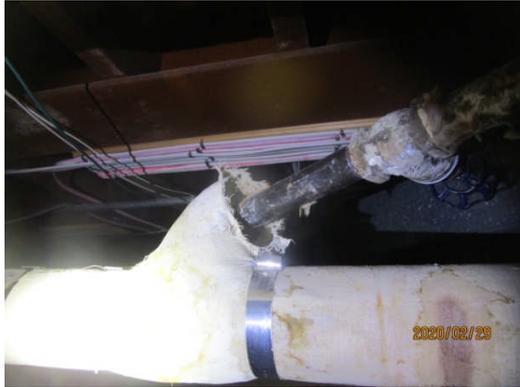
potential asbestos
